Steering Head Screw  
Models: M.Y. 2010 Multistrada 1200 (all versions)  
Recall Bulletin RCL-10-003

Date: Monday, July 26, 2010  
To: Dealer Principal, Service Manager, North American Dealer Network  
From: Austin Gray, Technical Director; Jonathan LaForte, Technical Manager

NHTSA Campaign I.D. Number: 10V-###  
Transport Canada Safety Recall I.D. Number: 10-###

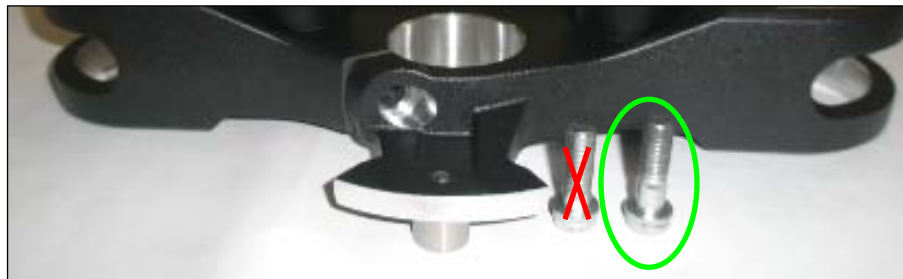
- On a production lot, an M8x25 8.8 screw has been incorrectly installed onto the steering head instead of the required M8x28 10.9 screw.

- Replace the steering head screw with the above-mentioned M8X28 10.9 screw, **Part. No. 771.5.726.8C**, and tighten to **18 Nm ± 5%** with graphitized grease.
